NIST NCSTAR 1-5A

Federal Building and Fire Safety Investigation of the World Trade Center Disaster

Visual Evidence, Damage Estimates, And Timeline Analysis

(Chapter 9 - Appendix C)

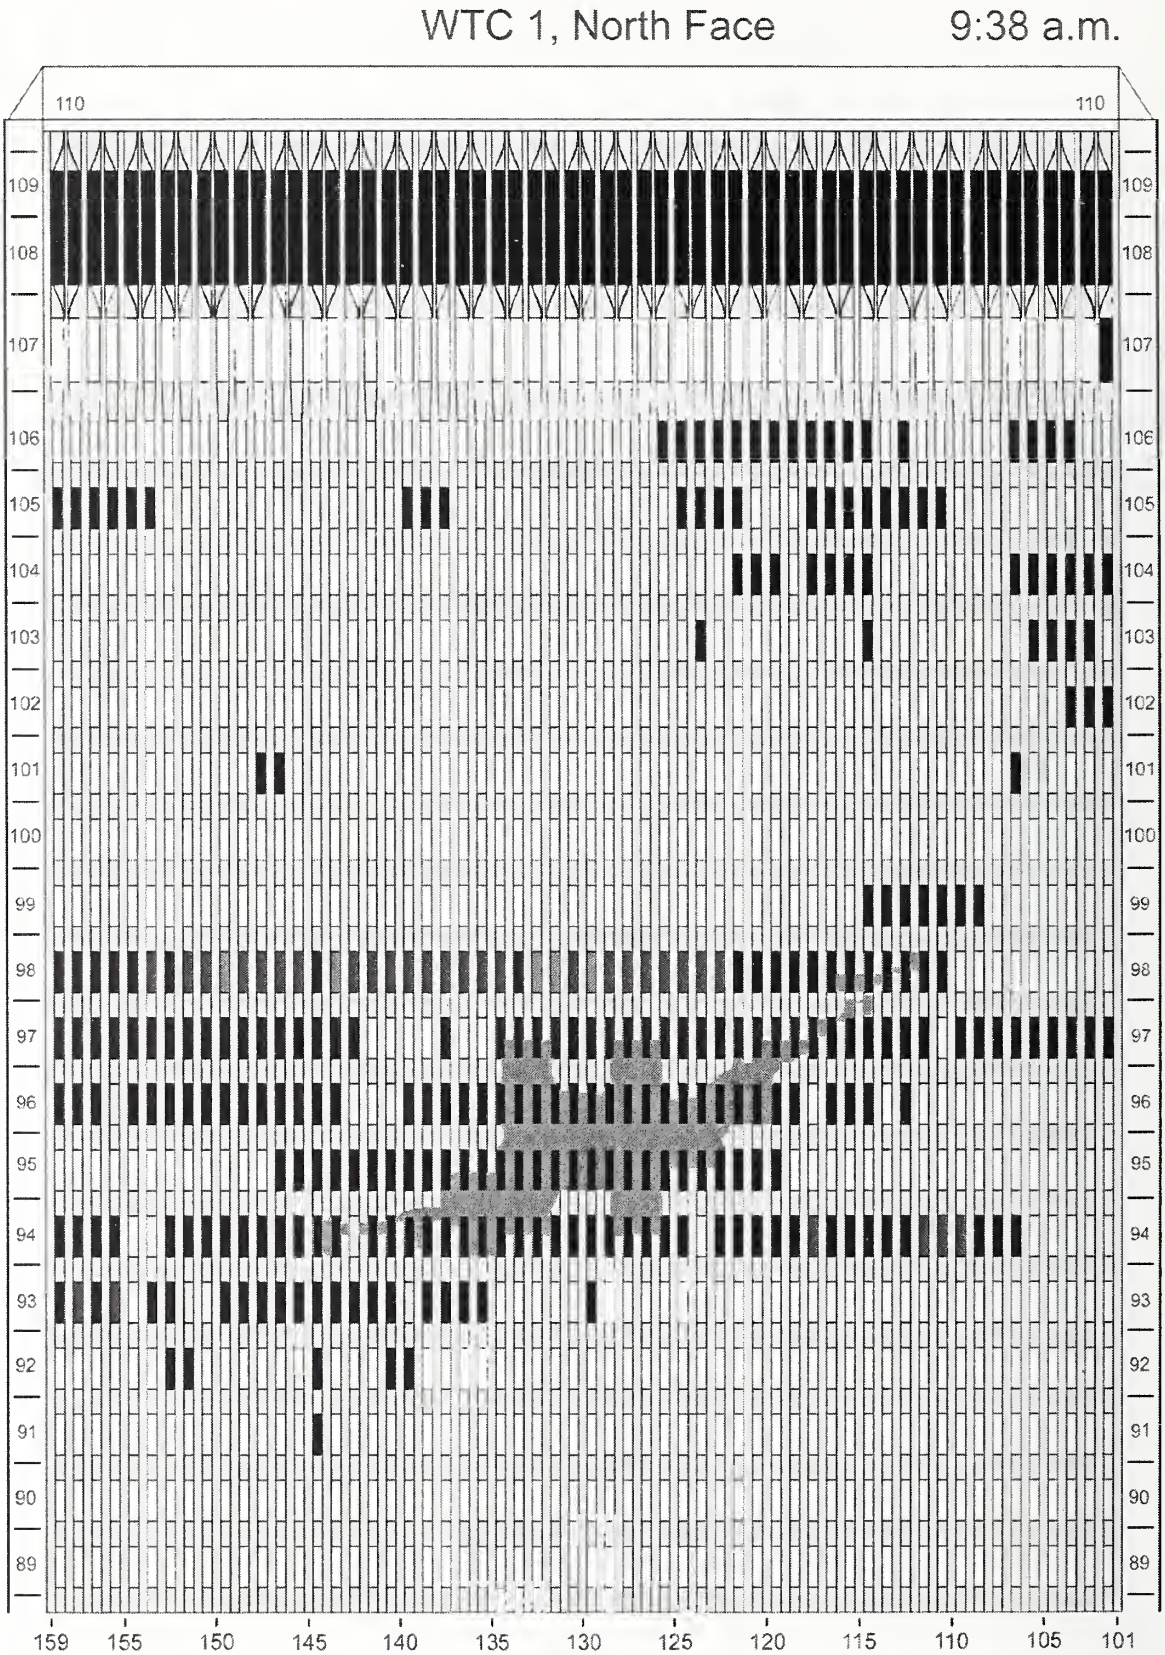
Figure C-33. Diagram of the north face of WTC 1 for floors 89 to 110 at 9:38 a.m. showing the condition of windows and locations of fires.

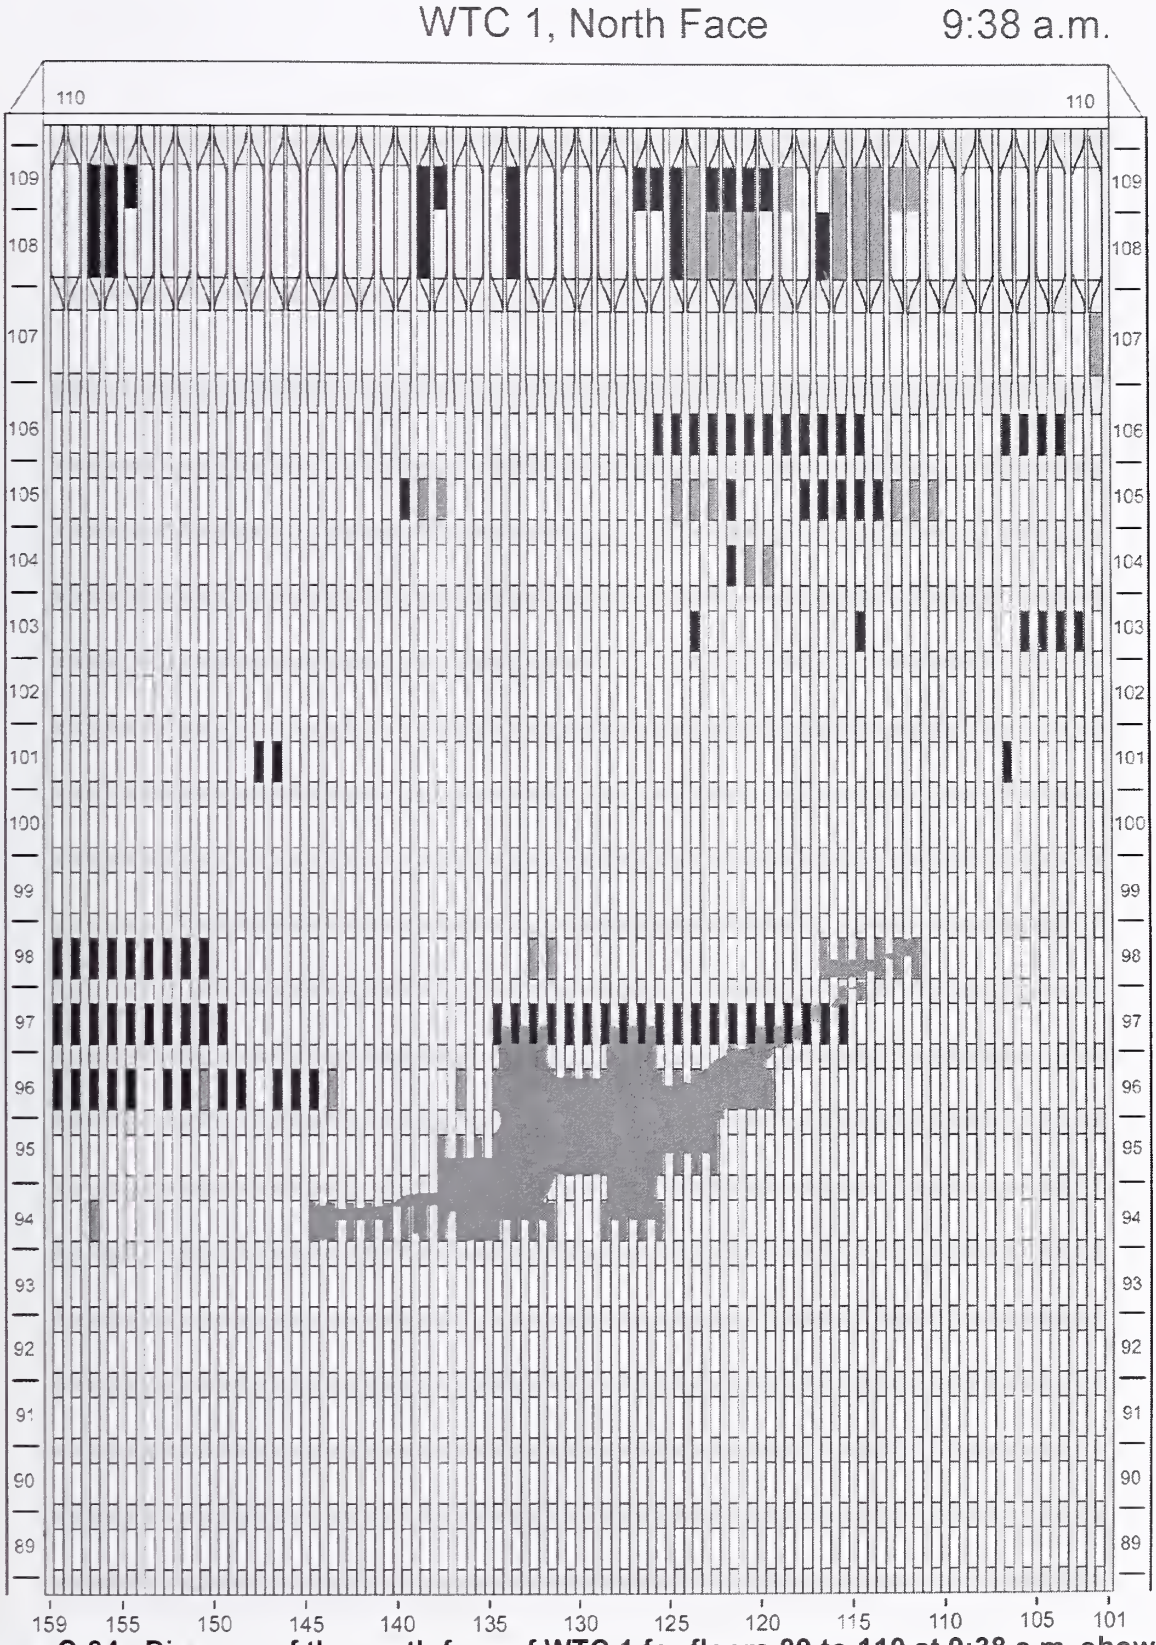
Figure C-34. Diagram of the north face of WTC 1 for floors 89 to 110 at 9:38 a.m. showing windows where smoke was observed and those that were hidden from view.

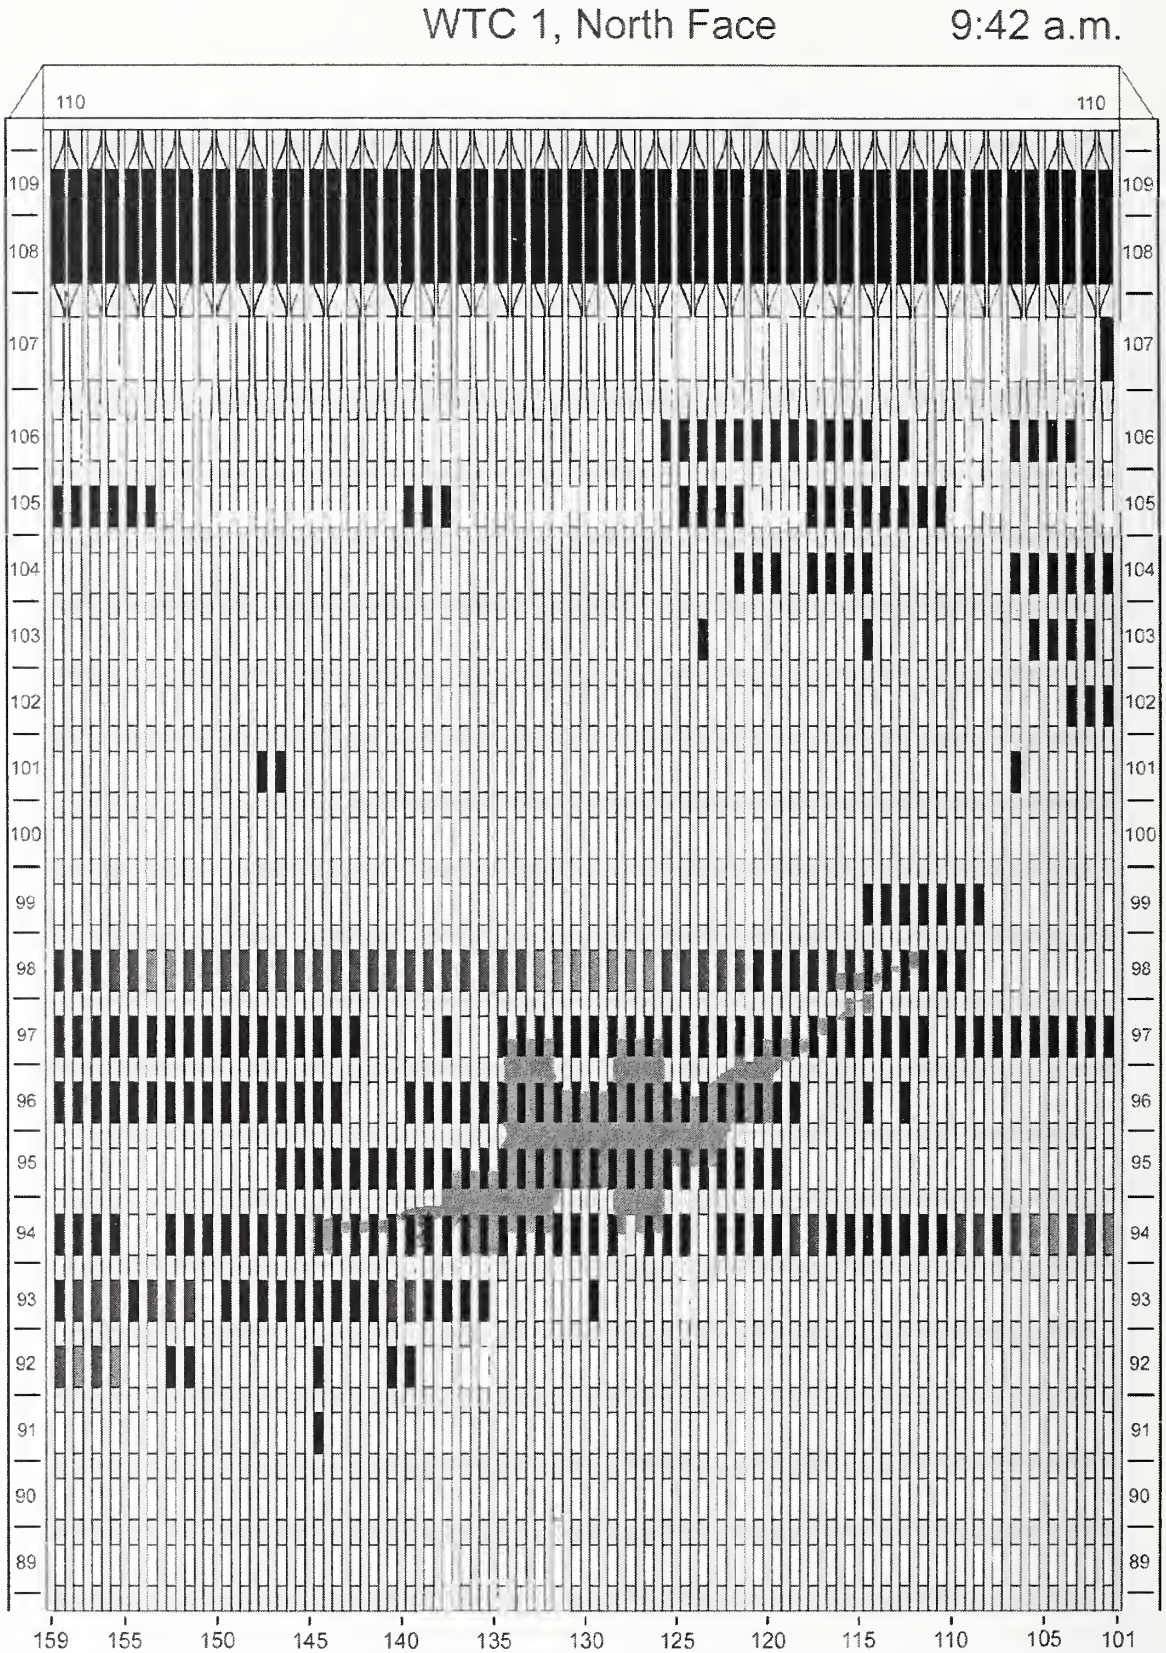
Figure C-35. Diagram of the north face of WTC 1 for floors 89 to 110 at 9:42 a.m. showing the condition of windows and locations of fires.

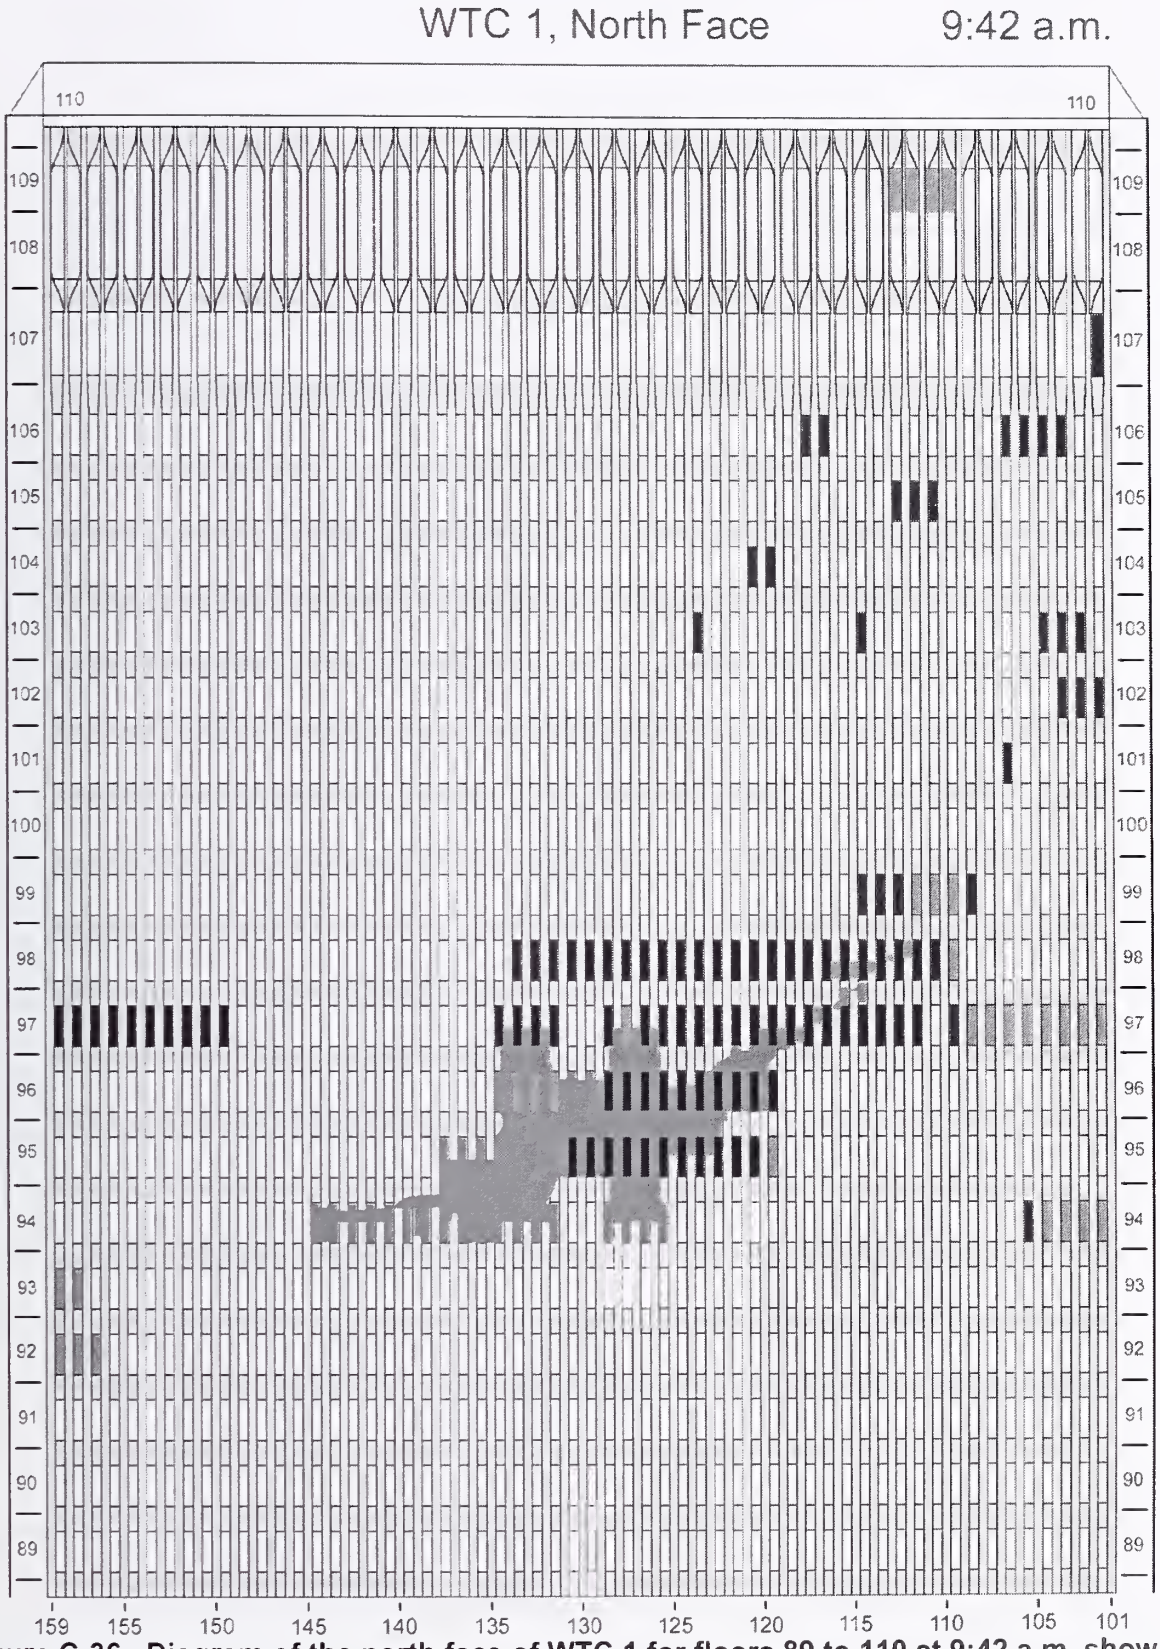
Figure C-36. Diagram of the north face of WTC 1 for floors 89 to 110 at 9:42 a.m. showing windows where smoke was observed and those that were hidden from view.

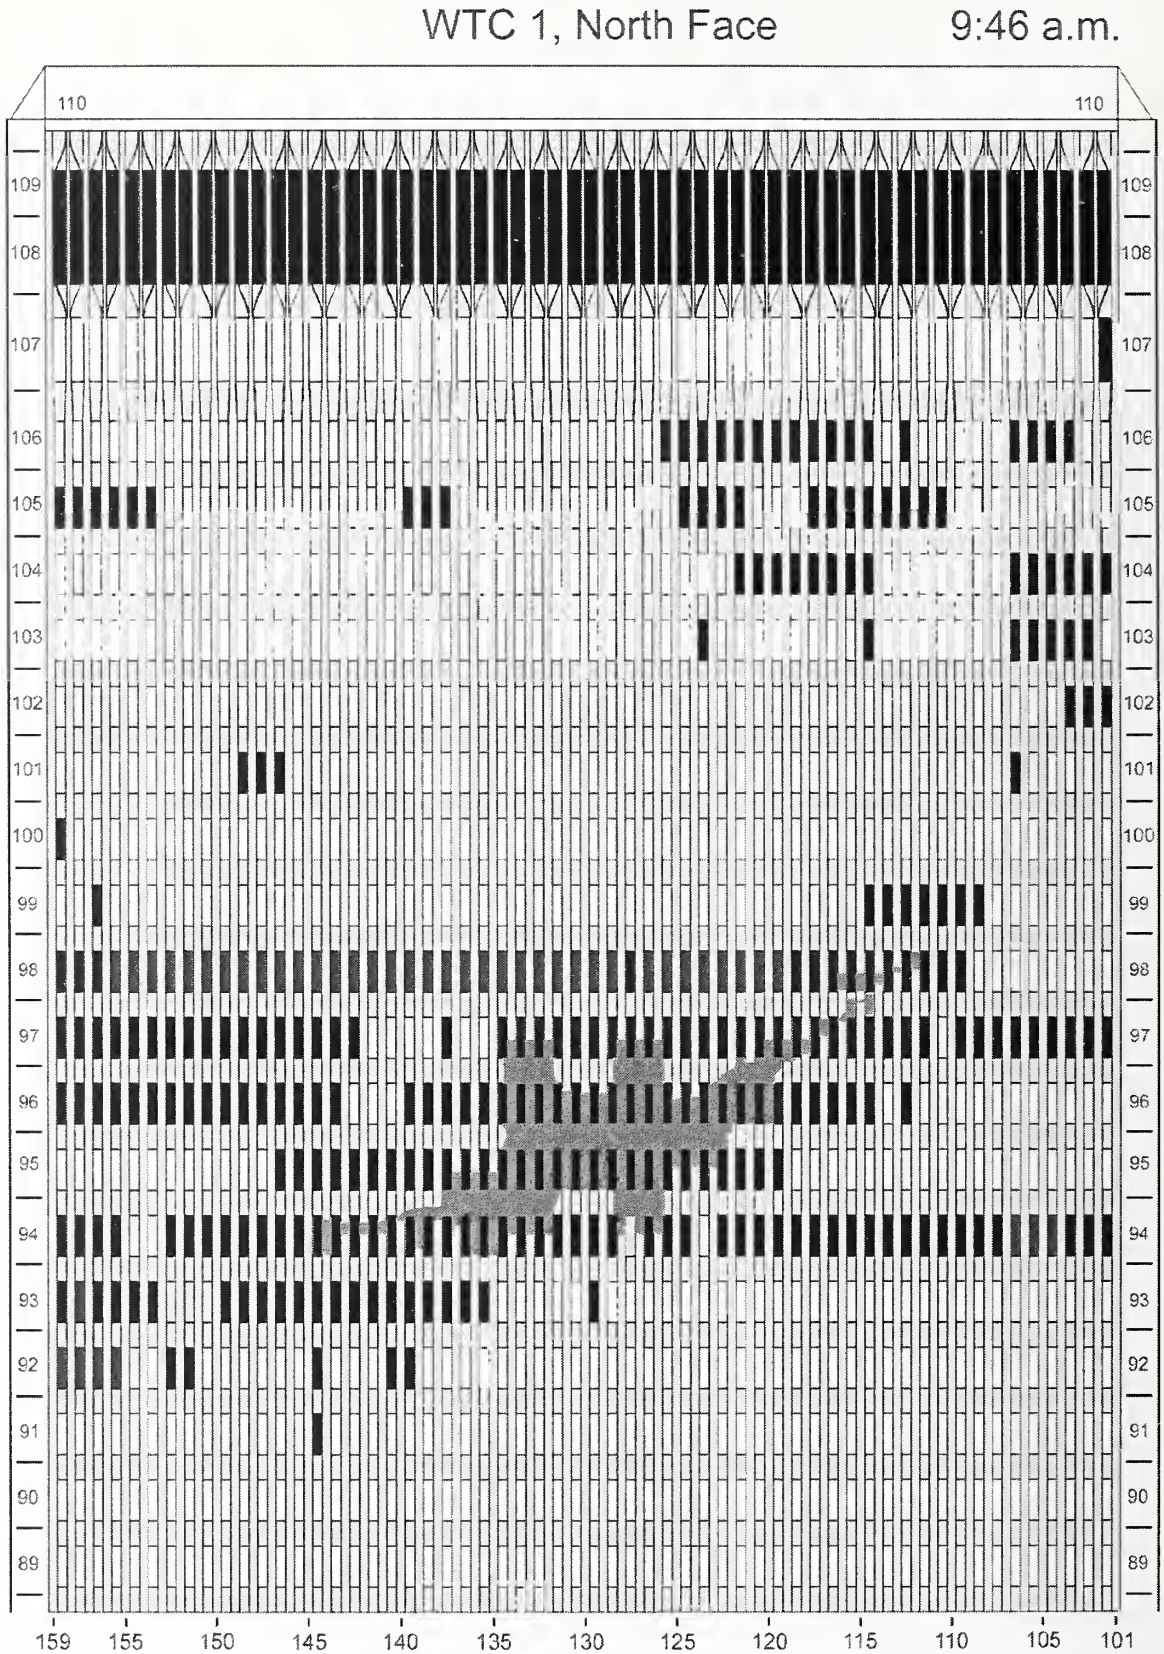
Figure C-37. Diagram of the north face of WTC 1 for floors 89 to 110 at 9:46 a.m. showing the condition of windows and locations of fires.

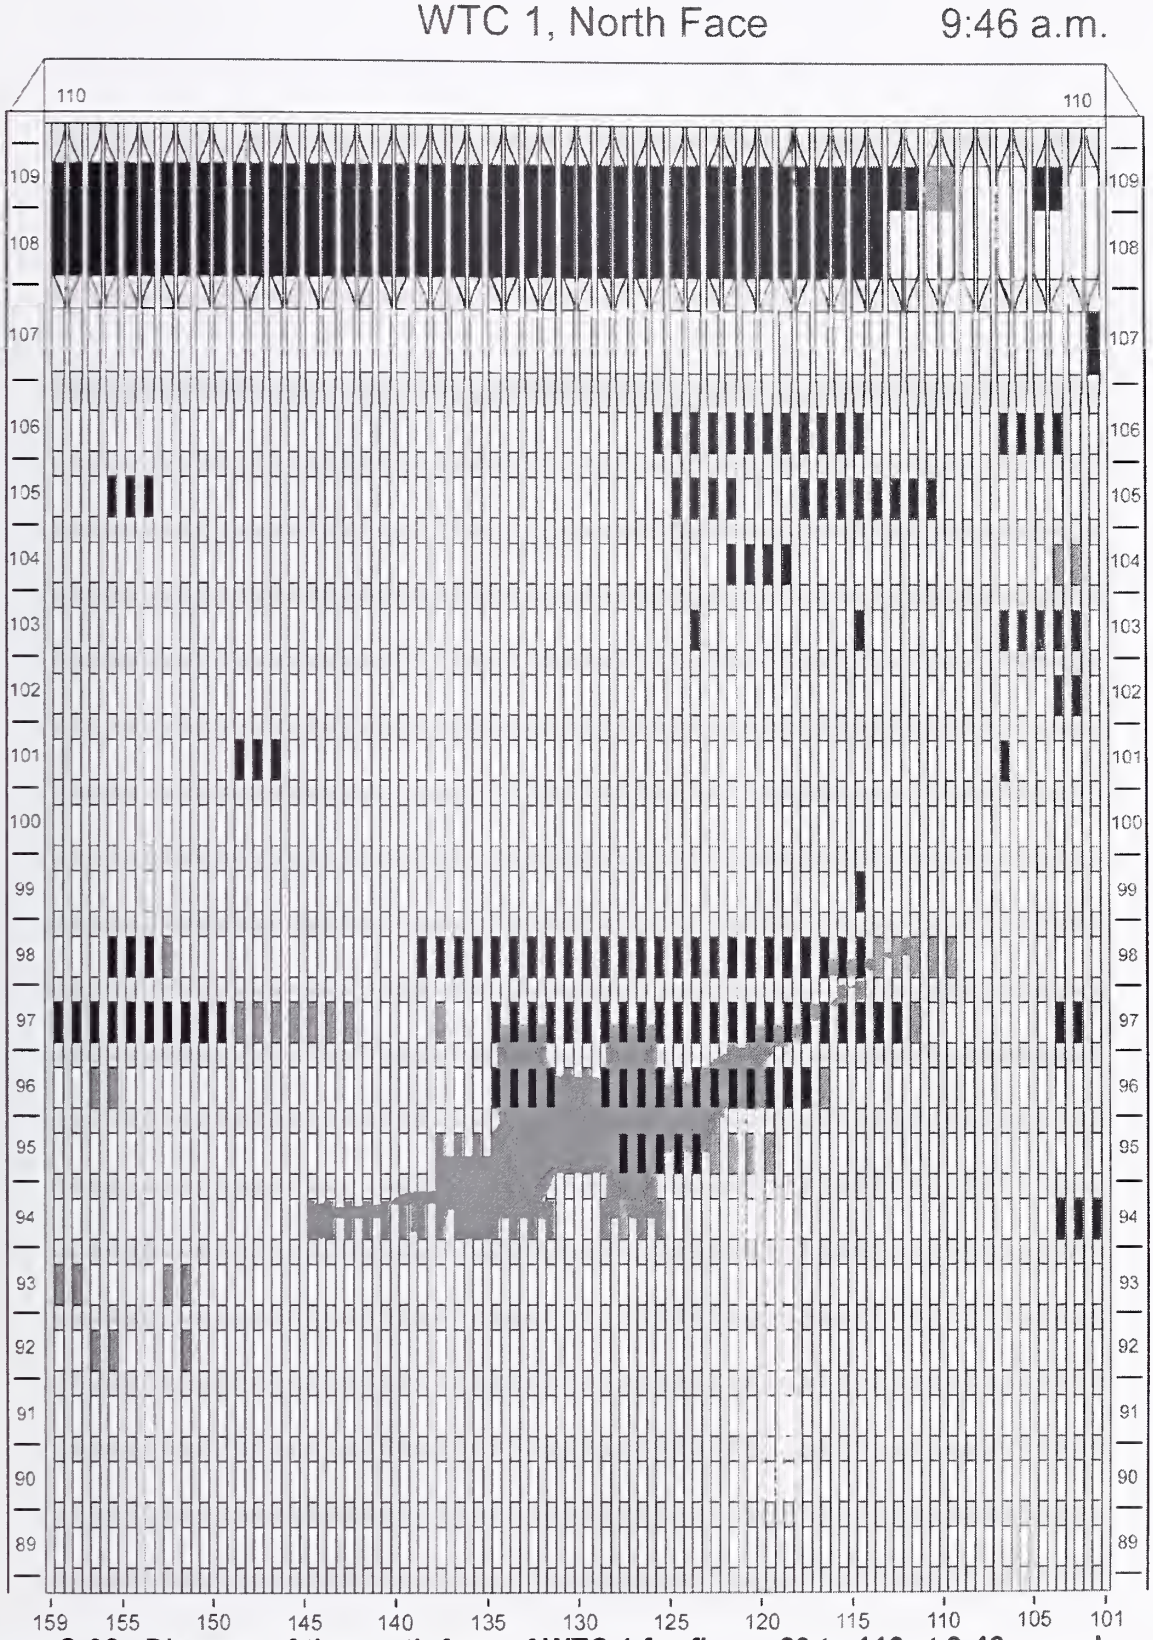
Figure C-38. Diagram of the north face of WTC 1 for floors 89 to 110 at 9:46 a.m. showing windows where smoke was observed and those that were hidden from view.

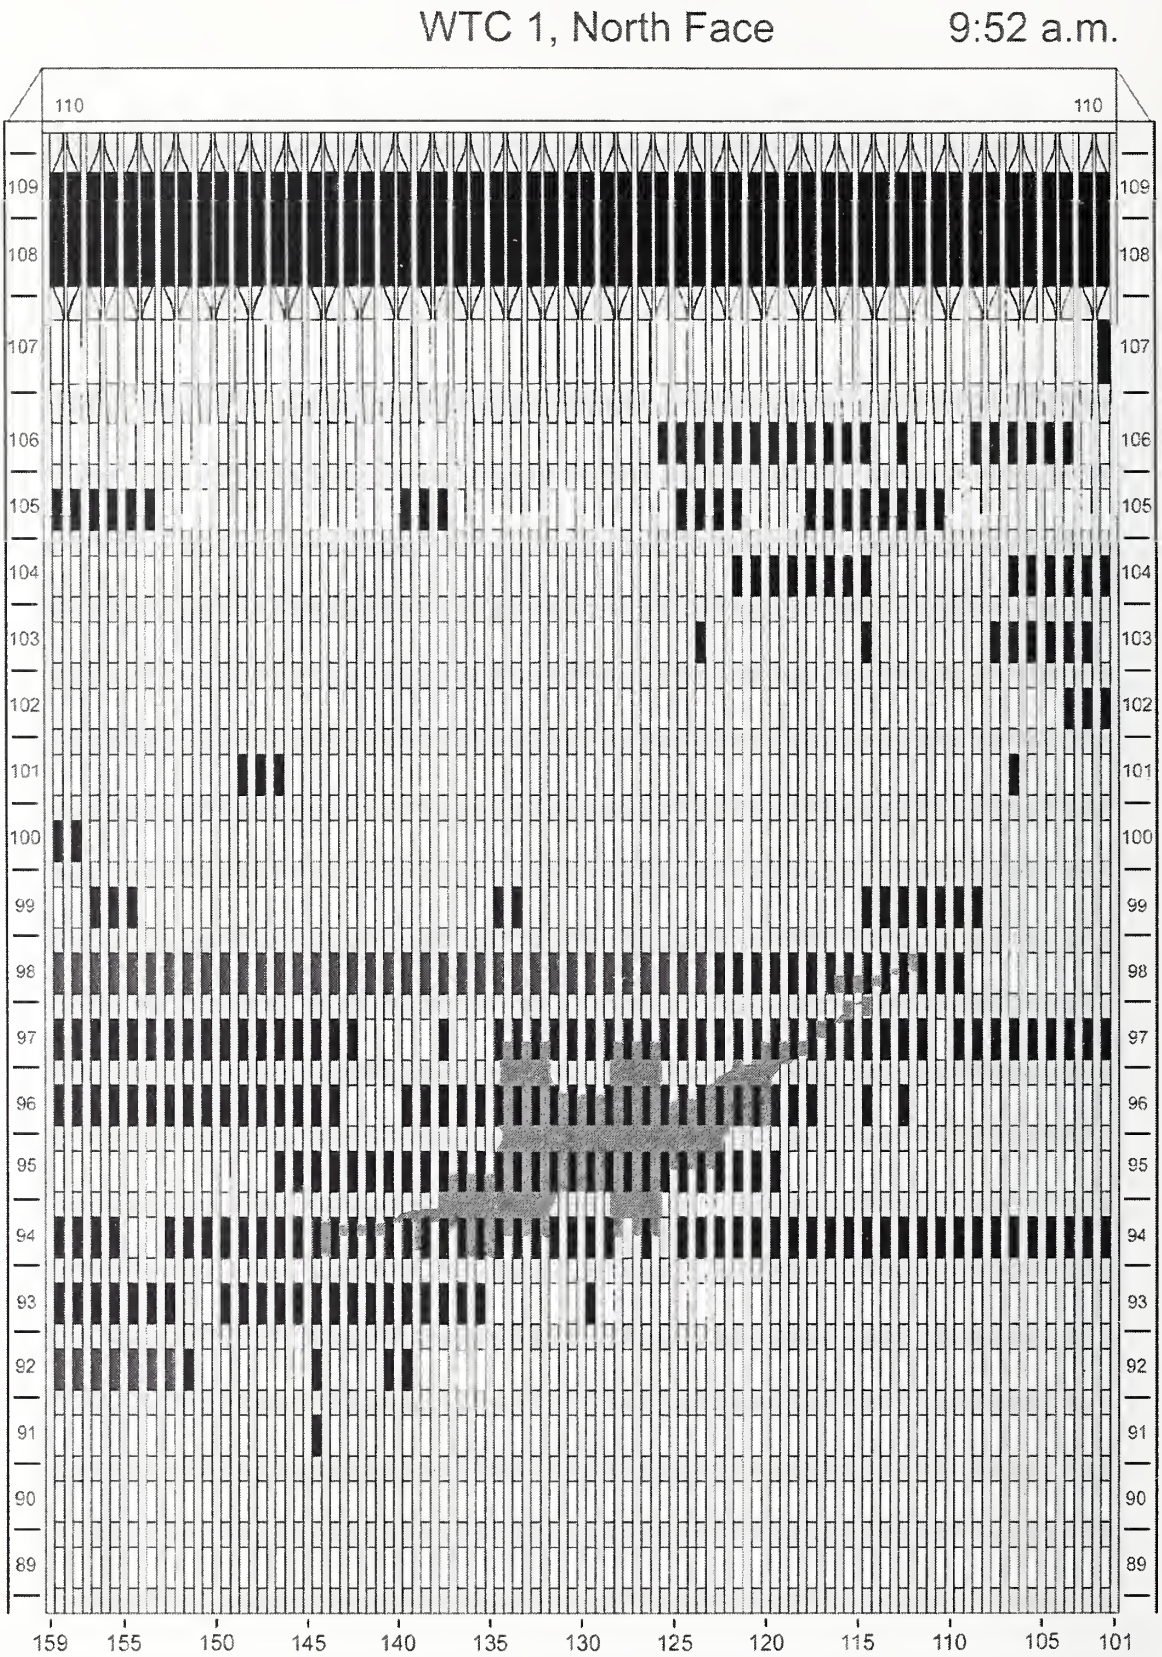
Figure C-39. Diagram of the north face of WTC 1 for floors 89 to 110 at 9:52 a.m. showing the condition of windows and locations of fires.

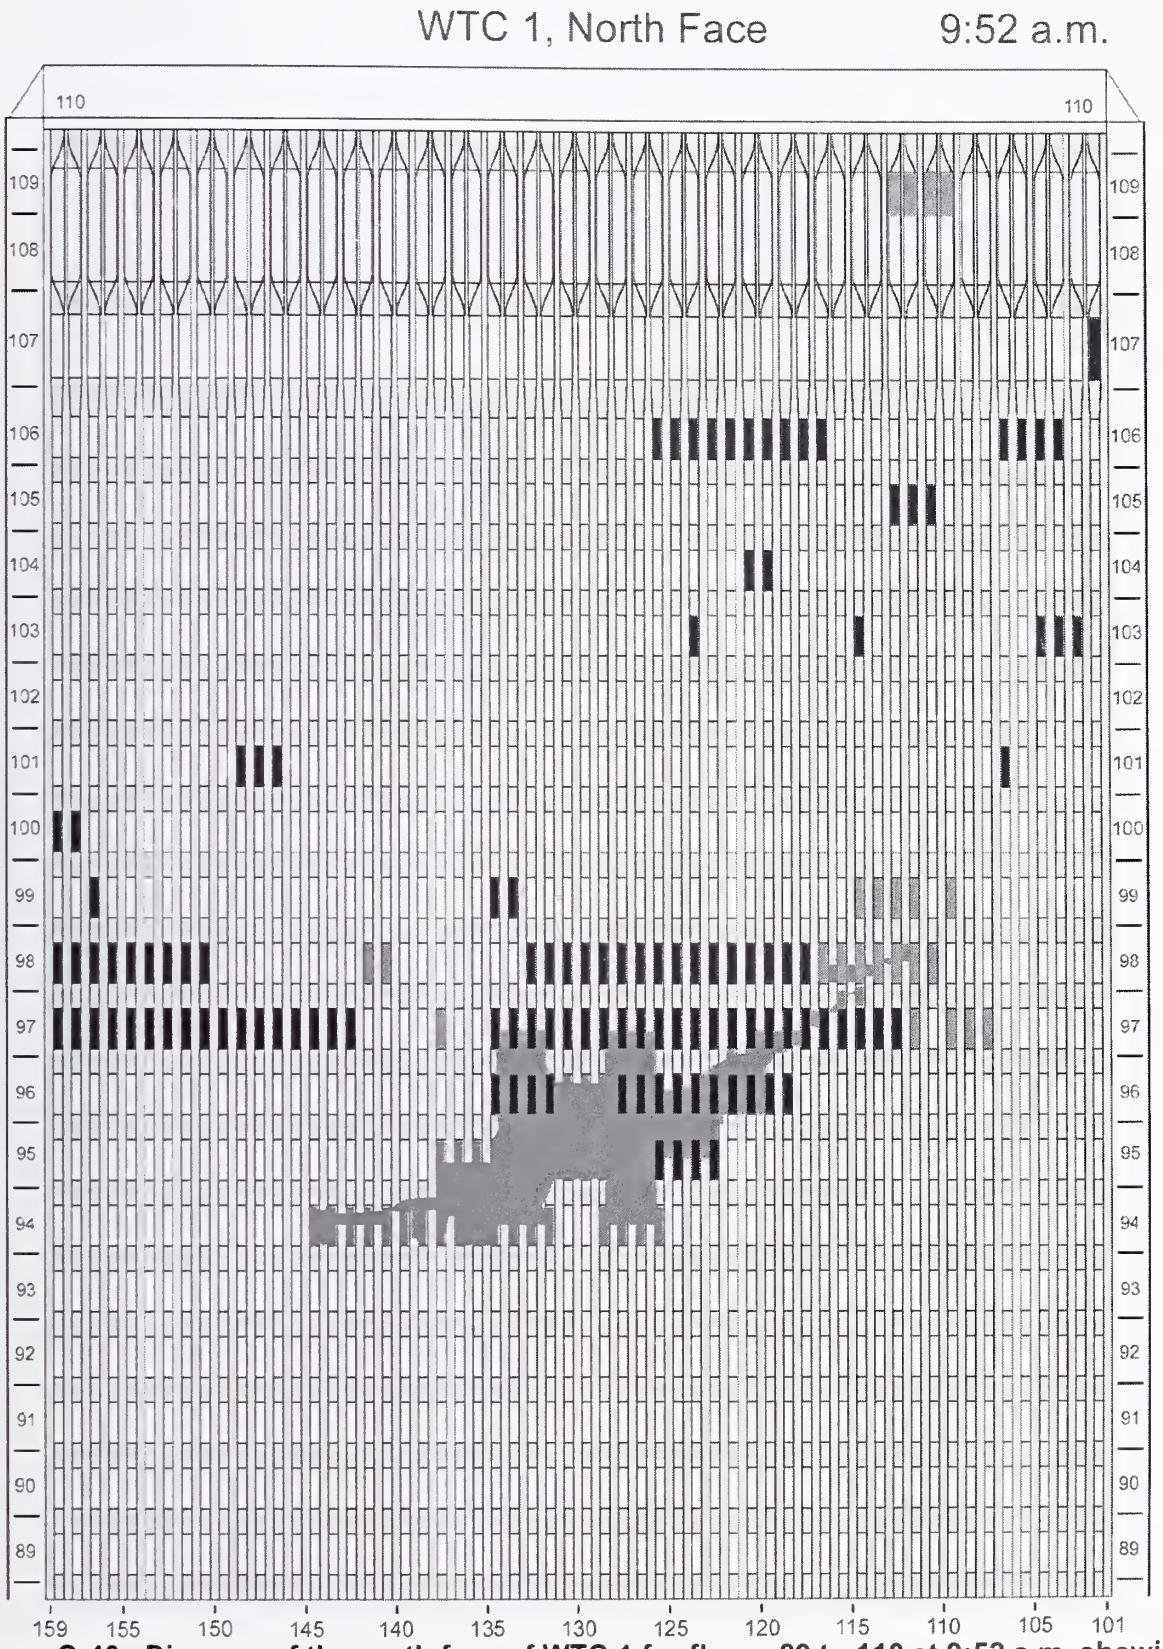
Figure C-40. Diagram of the north face of WTC 1 for floors 89 to 110 at 9:52 a.m. showing windows where smoke was observed and those that were hidden from view.

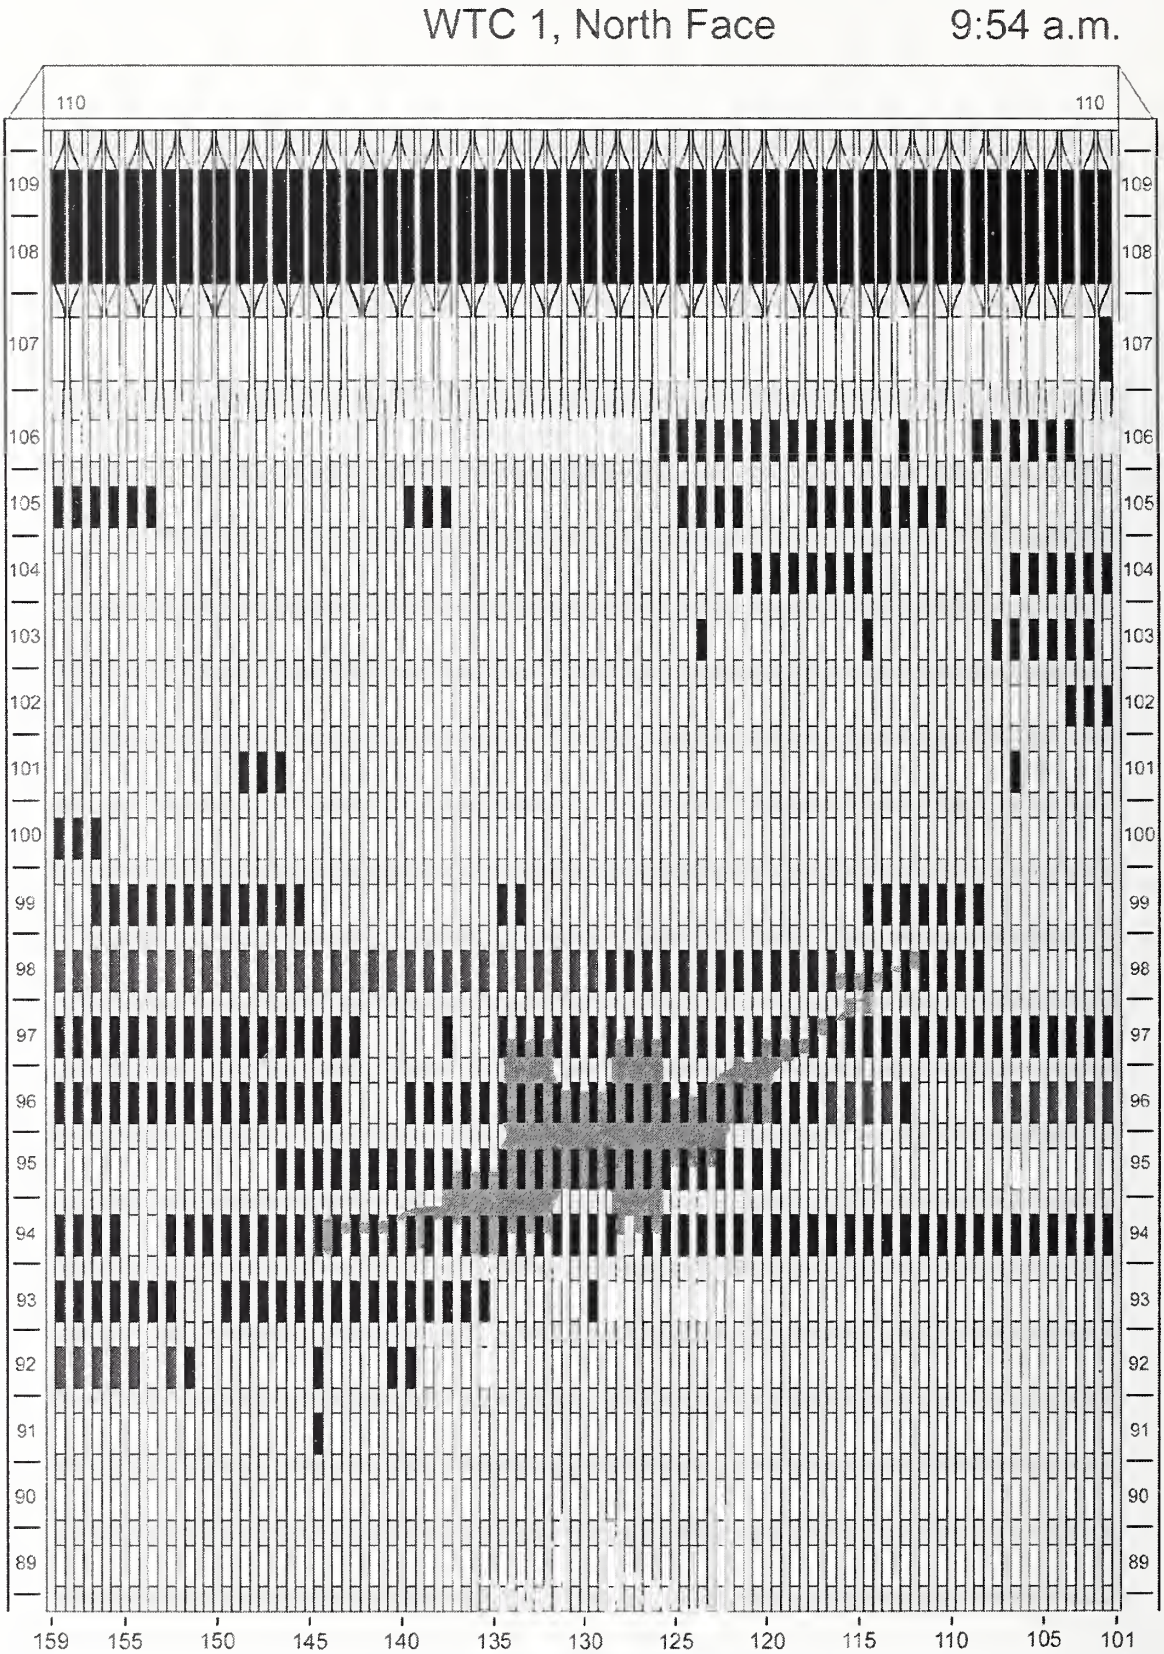
Figure C-41. Diagram of the north face of WTC 1 for floors 89 to 110 at 9:54 a.m. showing the condition of windows and locations of fires.

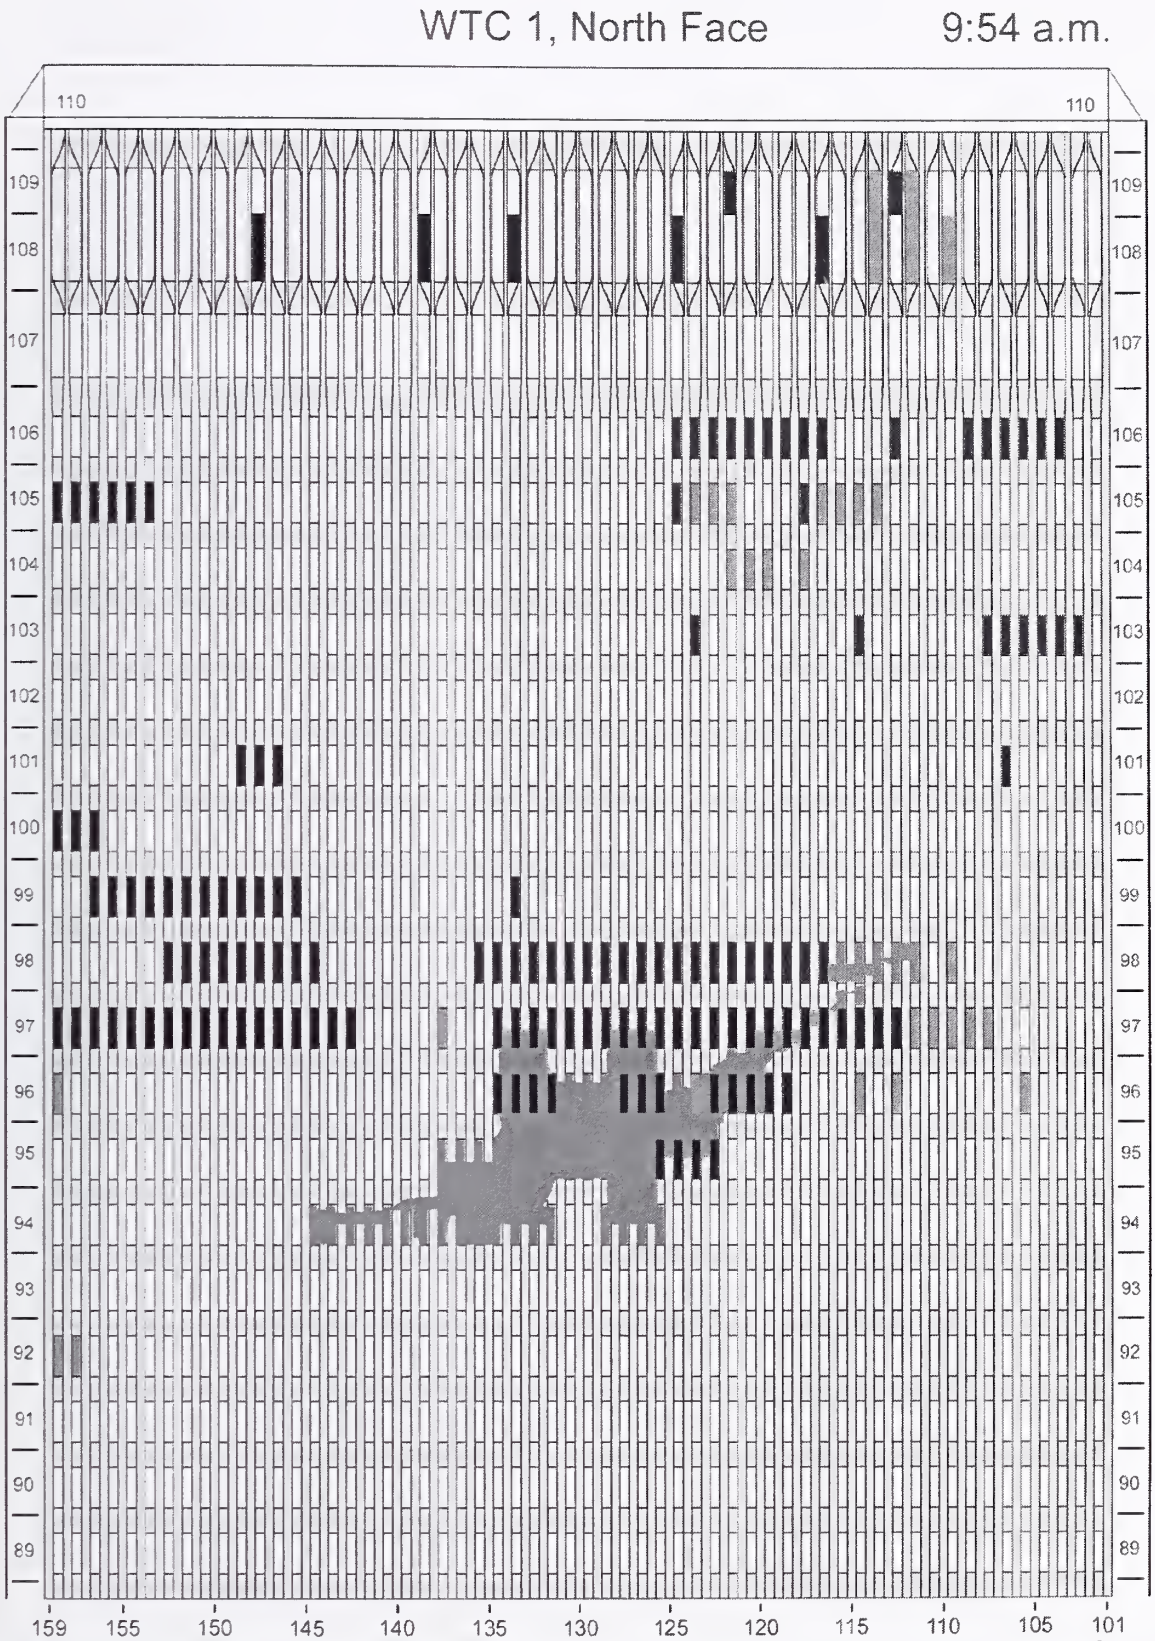
Figure C-42. Diagram of the north face of WTC 1 for floors 89 to 110 at 9:54 a.m. showing windows where smoke was observed and those that were hidden from view.

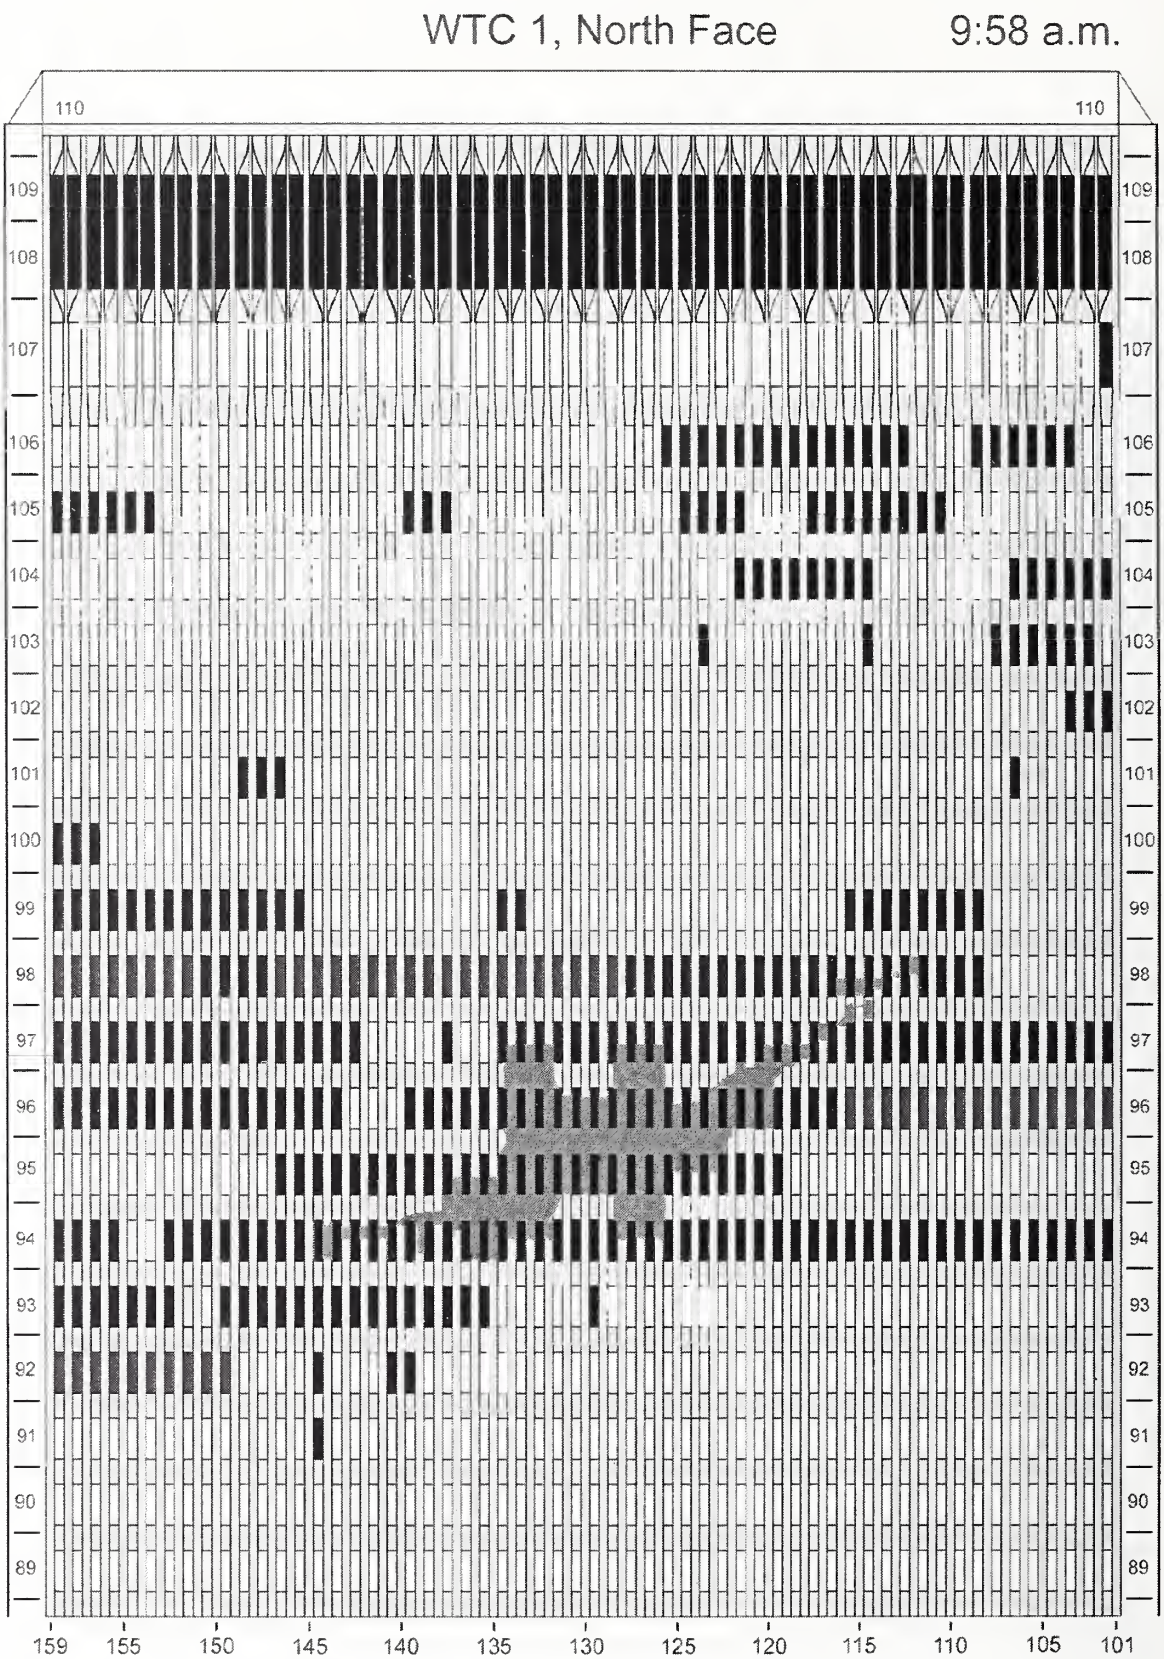
Figure C-43. Diagram of the north face of WTC 1 for floors 89 to 110 at 9:58 a.m. showing the condition of windows and locations of fires.
